PROTECTION OF STRUCTURAL STEEL  
ON THE  
P. R. R. Cortlandt Street Ferry Terminal  
New York City

BULLETIN NO. 40

# The Protection of Steel With Gunitite

## Without Reinforcing

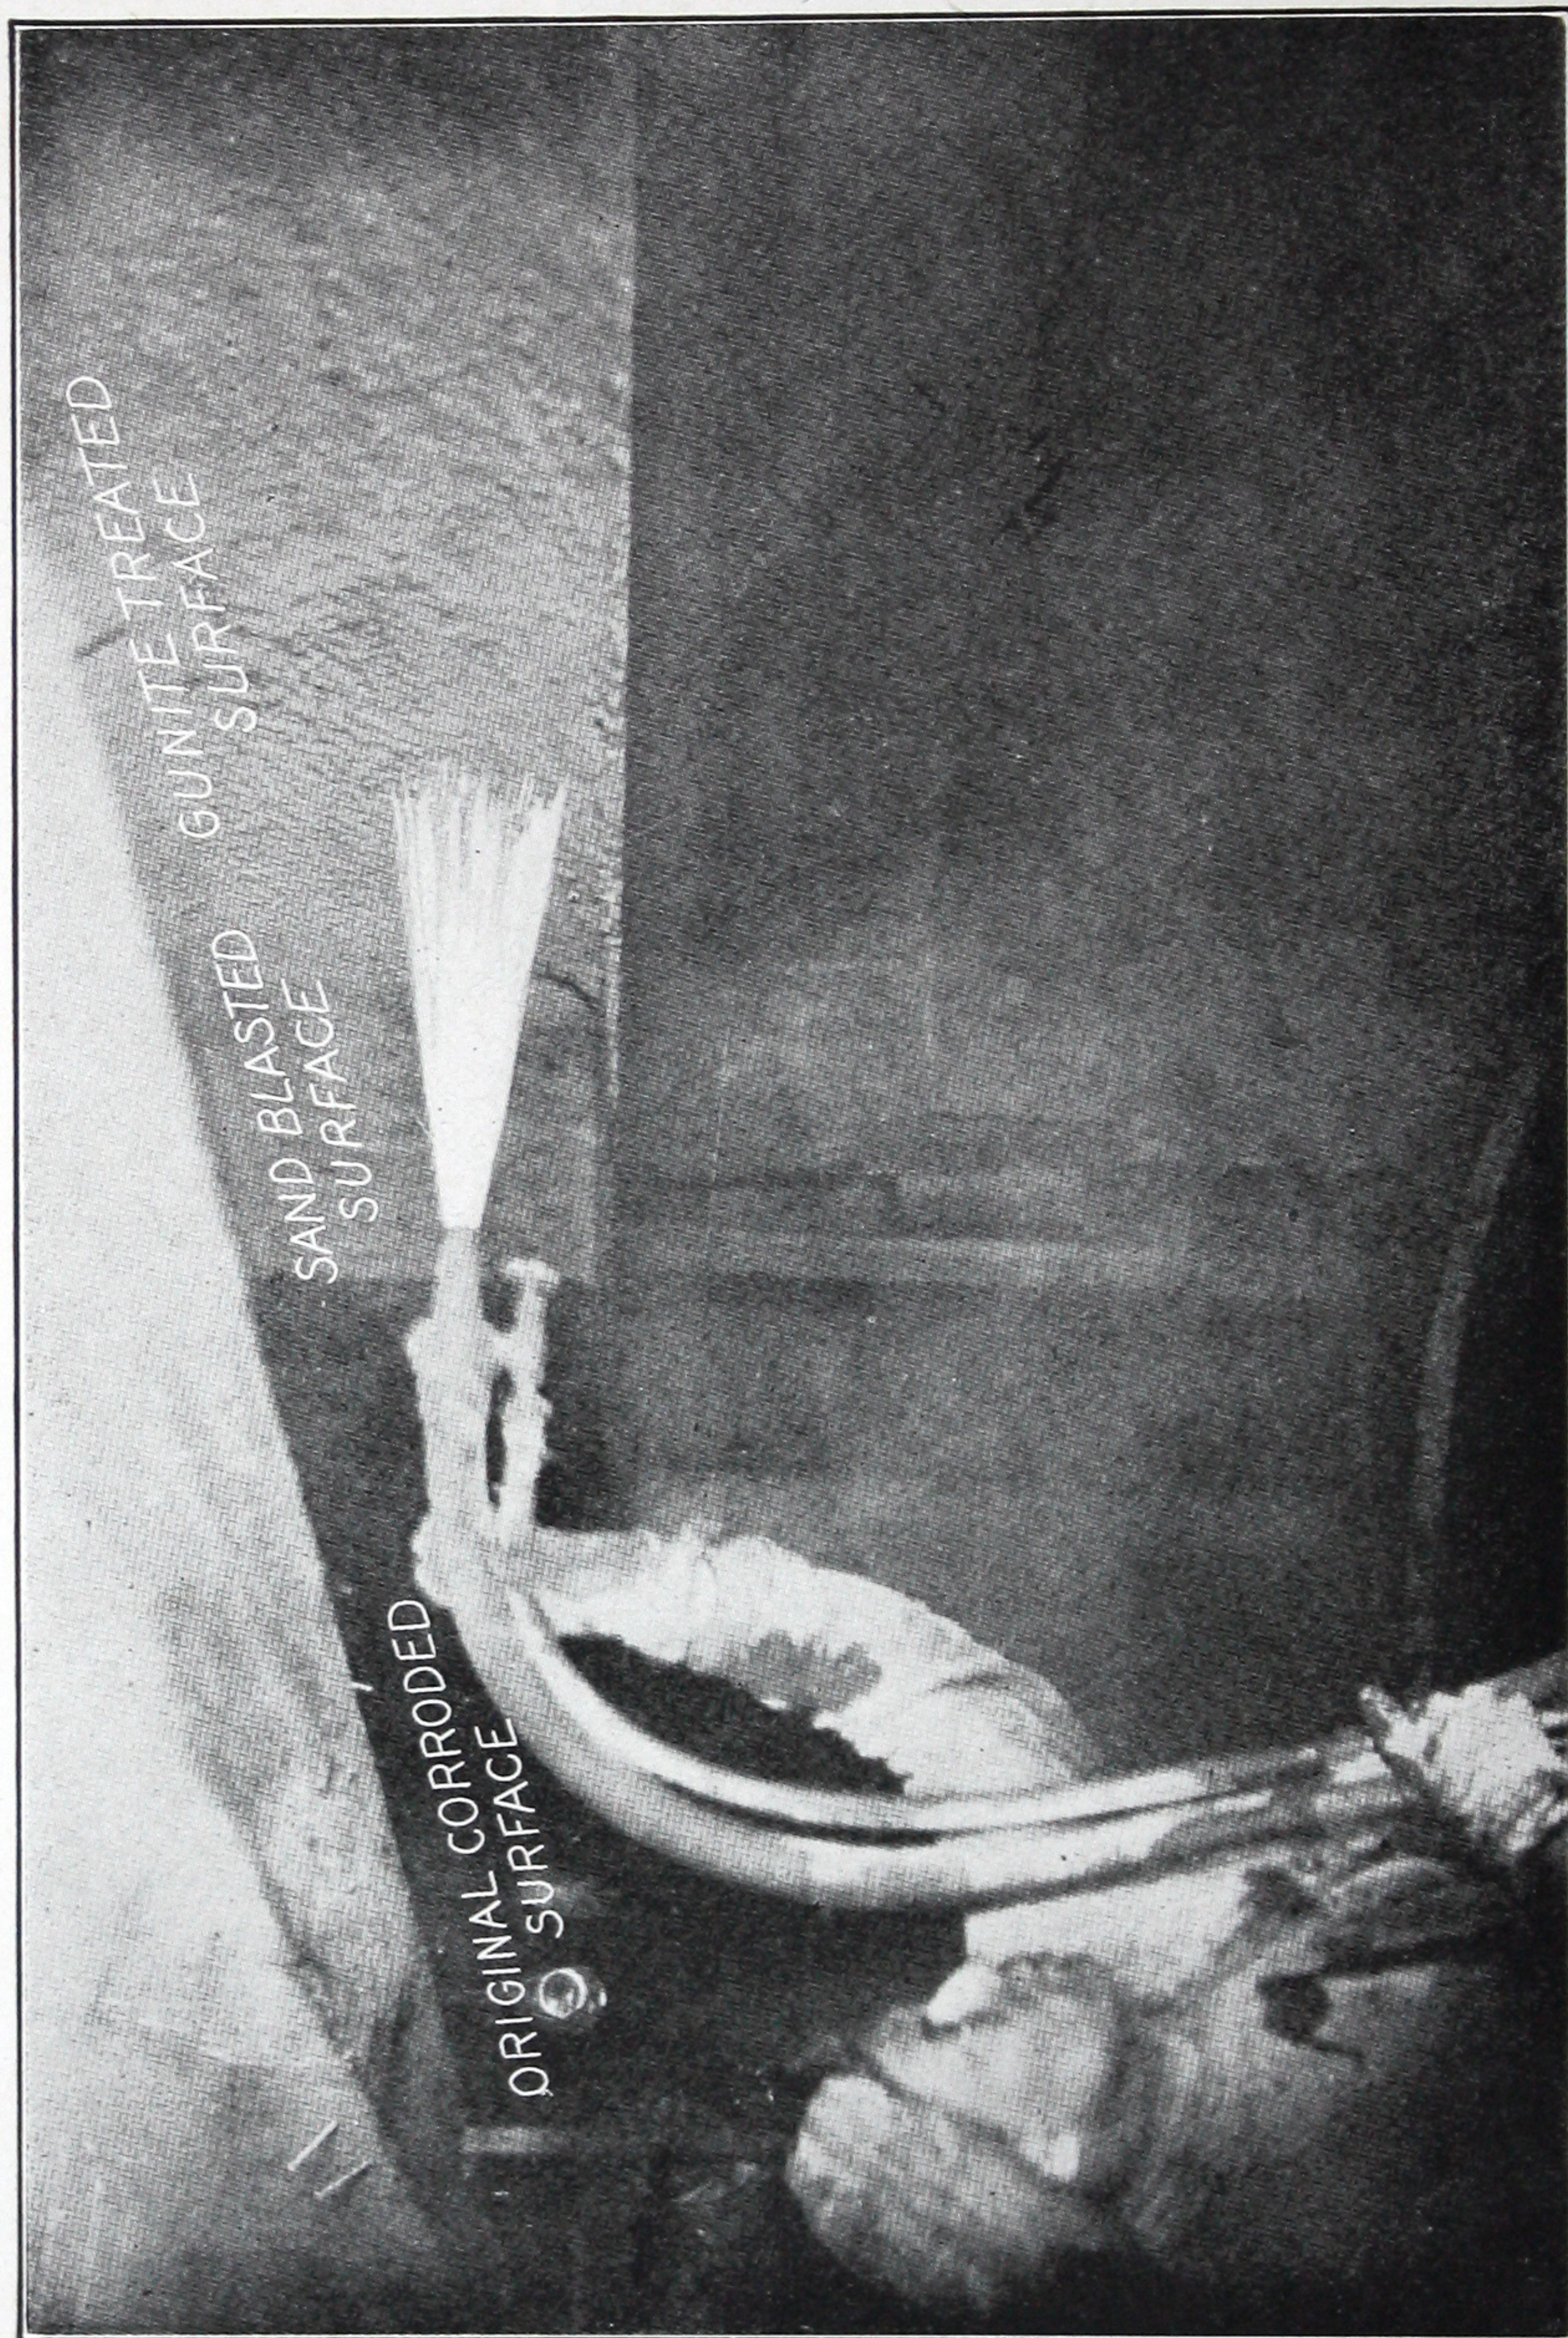
### THE THREE STAGES OF THE WORK

Original Surface of Steel. Surface after Sand-blasting. The Guniting Protective Coating.

The above tests satisfied the railroad company that the proposition was practical, and an equipment was taken for the work, comprising two sand-blast machines and a Cement-Gun. All the steel was first sand-blasted to gray metal, and this coated with Guniting to a thickness varying from  $\frac{1}{4}$ " to  $\frac{1}{2}$ ". The work was started early in October, and completed about January 1, 1915. Examination of the work that has been completed for four months, and over which the heaviest loads have passed, shows no sign of cracking, and the ringing sound given forth when struck with a hammer, indicates the strong and perfect bond of the Guniting to the steel.
